## **Bridge of Flowers & Light Enosburg, Vermont**

**Award:** ACEC Year 2000 Grand Award,  
Category B ("Transportation")

**Owner:** Village of Enosburg Falls

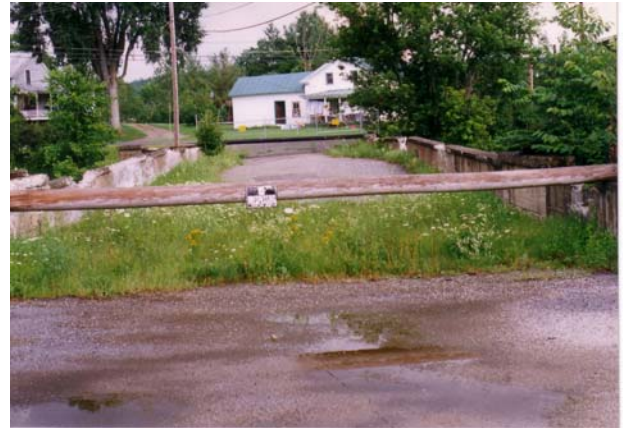
**Pre-Construction Condition (1996)**

**Problem:** The landmark structure featured in the Village logo of Enosburg Falls has long been the old Route 108 bridge. When Route 108 was relocated in the 1960's, the old arch bridge was abandoned in-place. By the 1990's the arch bridge was in serious disrepair. The Village was faced with 3 options: 1) let the bridge deteriorate and collapse into the Mississquoi River, 2) remove the landmark structure, or 3) restore the bridge.

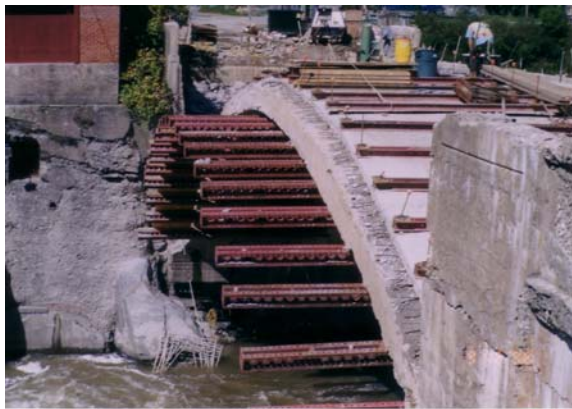
**Forming for Downstream Sidewall**

**Stabilization:** The first element of the engineering portion of work was the design and implementation of structural shoring for the existing bridge. During this pre-design phase, structural and geotechnical investigations were performed to assess the condition of the existing concrete and foundations. As originally expected, the main concrete arch was in good condition, but the sidewalls were distressed. The downstream sidewall required total replacement; the upstream sidewall was out-of-plumb and required re-attachment to the main arch and a new concrete railing. The south abutment required stabilization due to voids in the old stone foundation.

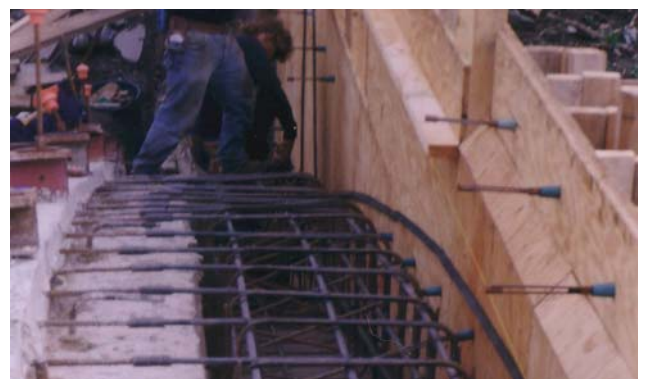
**Reinforcing for Arch Below the  
Downstream Sidewall**

**Design Approach:** The design concept required specific sequencing in the construction so as to minimize the chance for structural damage. In general, the construction sequence would be: 1) stabilize the sidewalls, 2) carefully remove the soil overburden so as to minimize unbalanced arch loading, 3) reinforce the main arch and re-attach the upstream sidewall by means of a 6"-8" thick concrete arch cap, 4) stabilize the foundations, 5) Color match the new concrete, 6) remove and re-build the downstream sidewall, 7) replace the fill over the arch with crushed stone, 8) patch and repair spalled concrete, 9) construct the concrete railings and planters, and 10) install the brick pavers, granite benches, lights and landscaping.

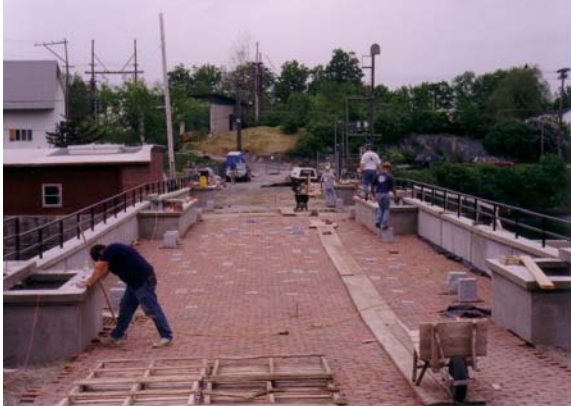
**Setting Brick Pavers**
