## Waterfront Housing Burlington, Vermont

**Owner:** Housing Vermont & Burlington Community Land Trust

**Services Provided:** Civil, geotechnical and structural engineering, plus construction inspection & testing.

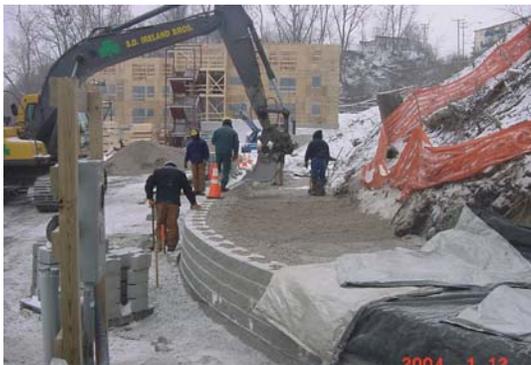
**MSE Wall at Parking Lot (Southeast)**

**Design Approach:** In order to improve slope stability and reduce the chance of contact with the soil contaminants, the site was capped with 4 to 10 feet of soil. Reinforced slopes were used east of the proposed building and a soil-reinforced masonry wall was used east of the parking lot. An additional block retaining wall was required to separate the project from existing railroad tracks along the western portion of the site. Site access was provided by a 400-foot long extension of Lake Street. Stormwater treatment was achieved by means of an off-site sand filter connected to the new stormwater outfall for Lake Street Extension. The new sanitary pump station required a radio link to the receiving College Street pump station to prevent operation during any shutdowns of that station.

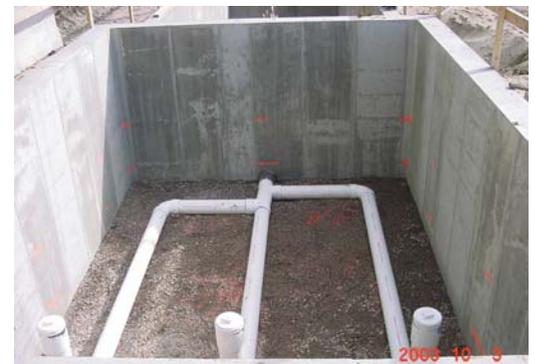
**Sand Filter for Stormwater**

**Concept Design:** Site grading concepts had to incorporate slope stability concerns with the findings of the Phase 2 Environmental Assessment Report. Site stormwater treatment needed to result in 80% removal of TSS and 40% removal of phosphorus for LEED certification. The limited shape and size of the lot did not permit the use of aboveground treatment ponds or ditches. It was also found desirable for the LEED certification to leave most of the old foundations intact. Sanitary sewage was to be disposed of by means of a new gravity sewer and pump station.
